Manhole Inspection Summary

Manhole # S45K__025MH

Location Address: **1930 alicenna st** Cross Street: **s washington st**

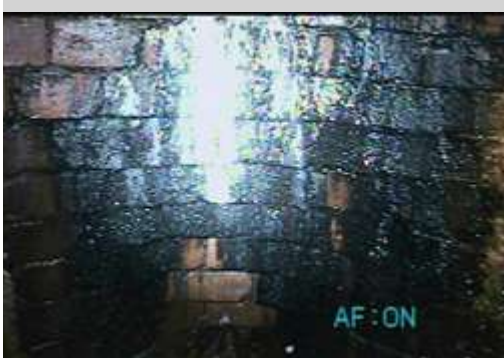
Defect 1

Infiltration: ☐ None ☒ **Joint** ☐ Cracks ☒ **Mortar** ☐ Roots ☒ **Wall**

infiltration from barrel joint, mortar, & wall

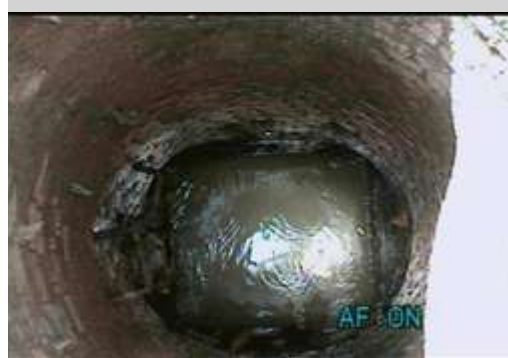
Defect 4

Steps Count: **7** Missing: **4** ☒ **Corroded**

steps missing/corroded

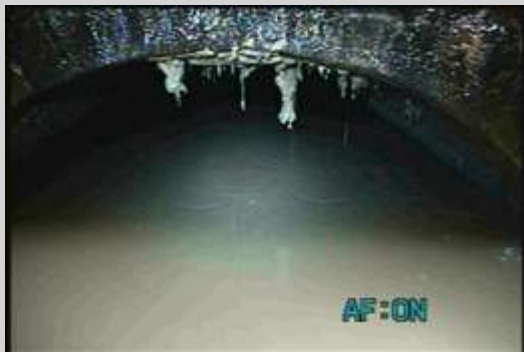
12 O'Clock Outflow

48 in. Circular Gravity Sewer
Pipe Out @ 12 O'Clock

Infiltration: **None** Pipe Seal Cond: **Unknown**

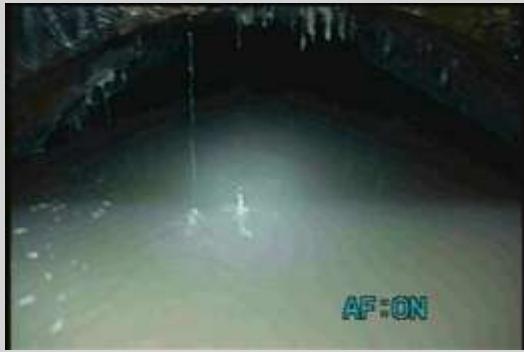
Pipe In @ 6 O'Clock

48 in. Circular Gravity Sewer

Infiltration: **None** Pipe Seal Cond: **Unknown**

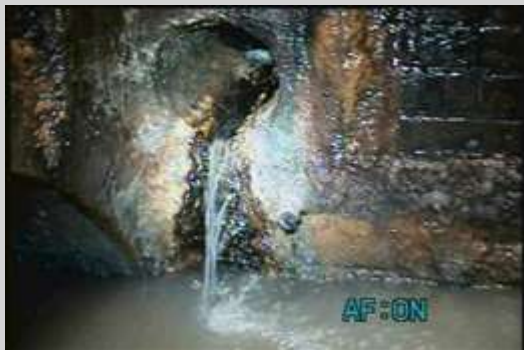
Pipe In @ 9 O'Clock

8 in. Circular Gravity Sewer

Infiltration: **None** Pipe Seal Cond: **Unknown**
